Impacts of tephra fall on buildings from the
2017-2018 eruption of Manaro Voui volcano,
Ambae Island, Vanuatu

A thesis

Master of Science in Geology

The University of Canterbury

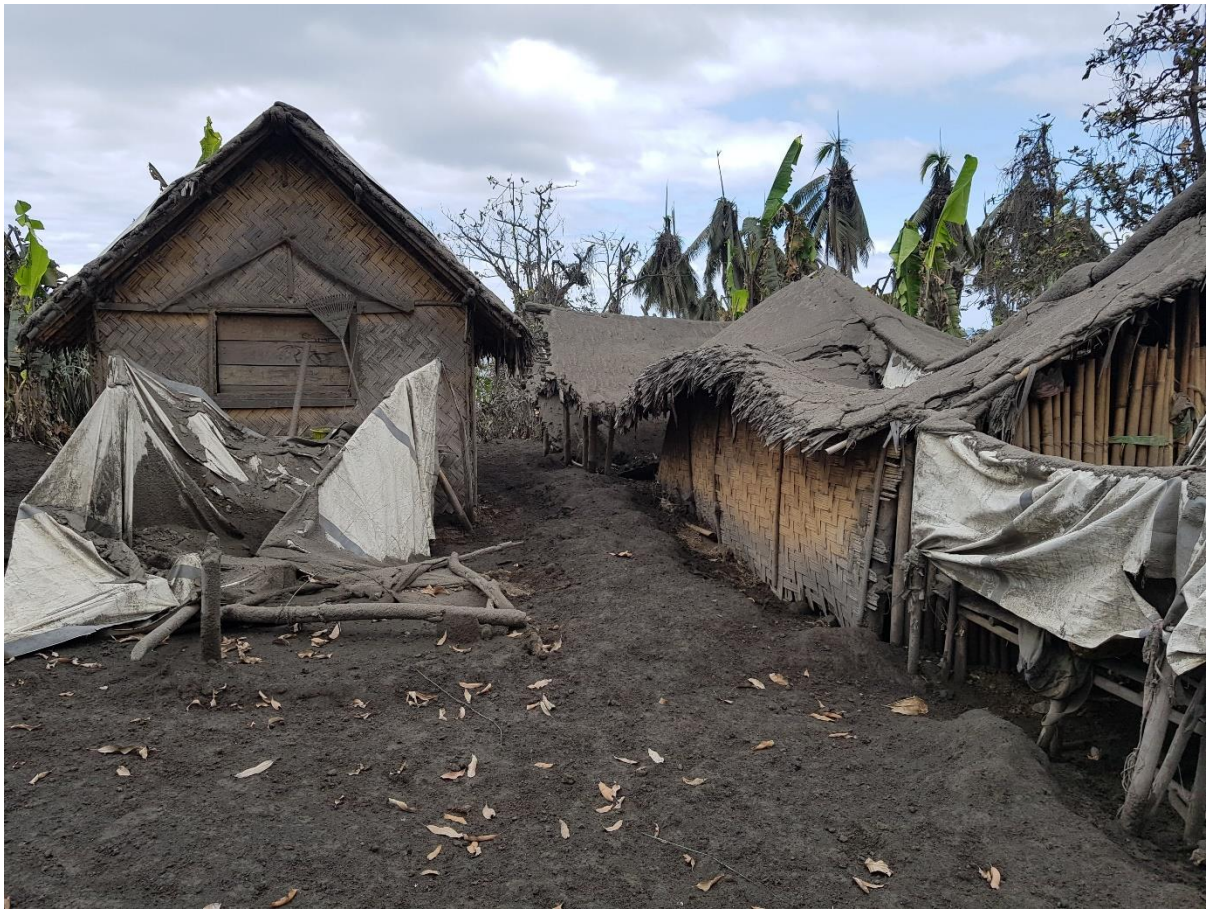
Buildings constructed using traditional materials and design in Sakao village, South Ambae, Vanuatu, that were damaged from the July 2018 tephra fall from Manaro Voui volcano (photo credit Carol Stewart).

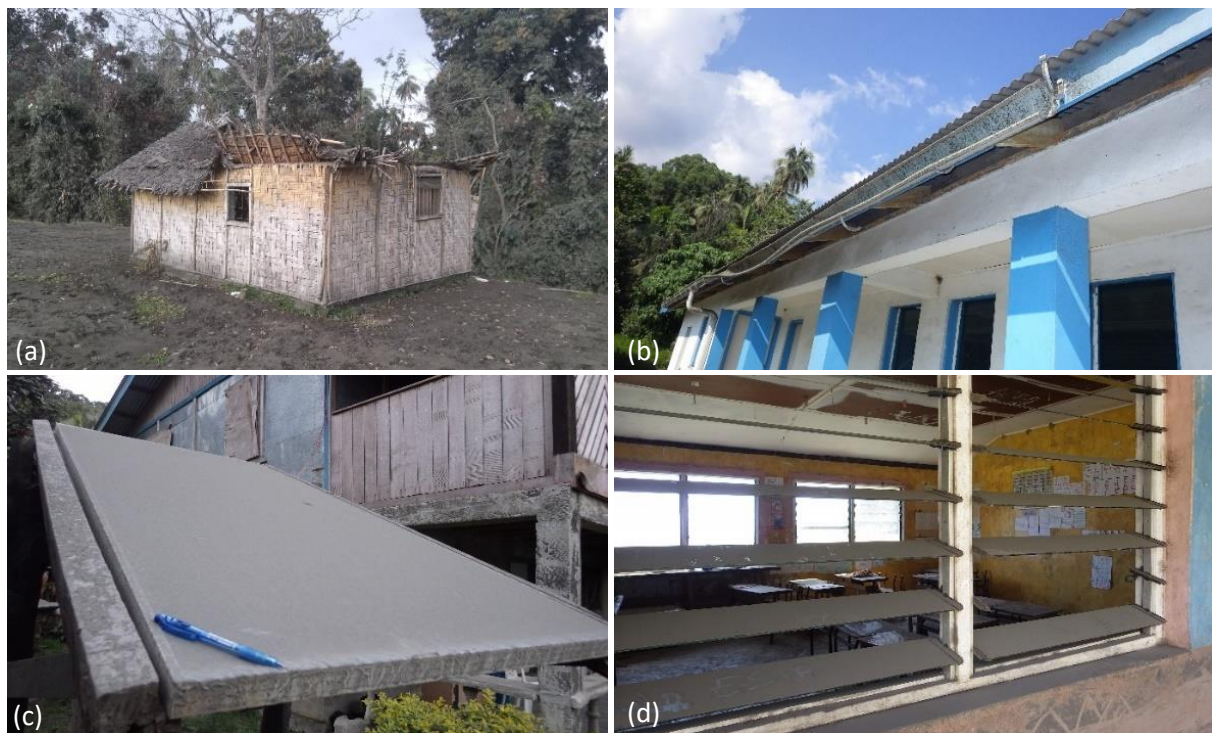
Figure 2.6 Four mechanisms by which tephra fall directly impacts buildings. (a) Structural damage (b) non structural damage to gutter system (c) disruption to the solar panel functionality (electricity source) (d) contamination of a building interior and exterior (Photo credit Susanna Jenkins)

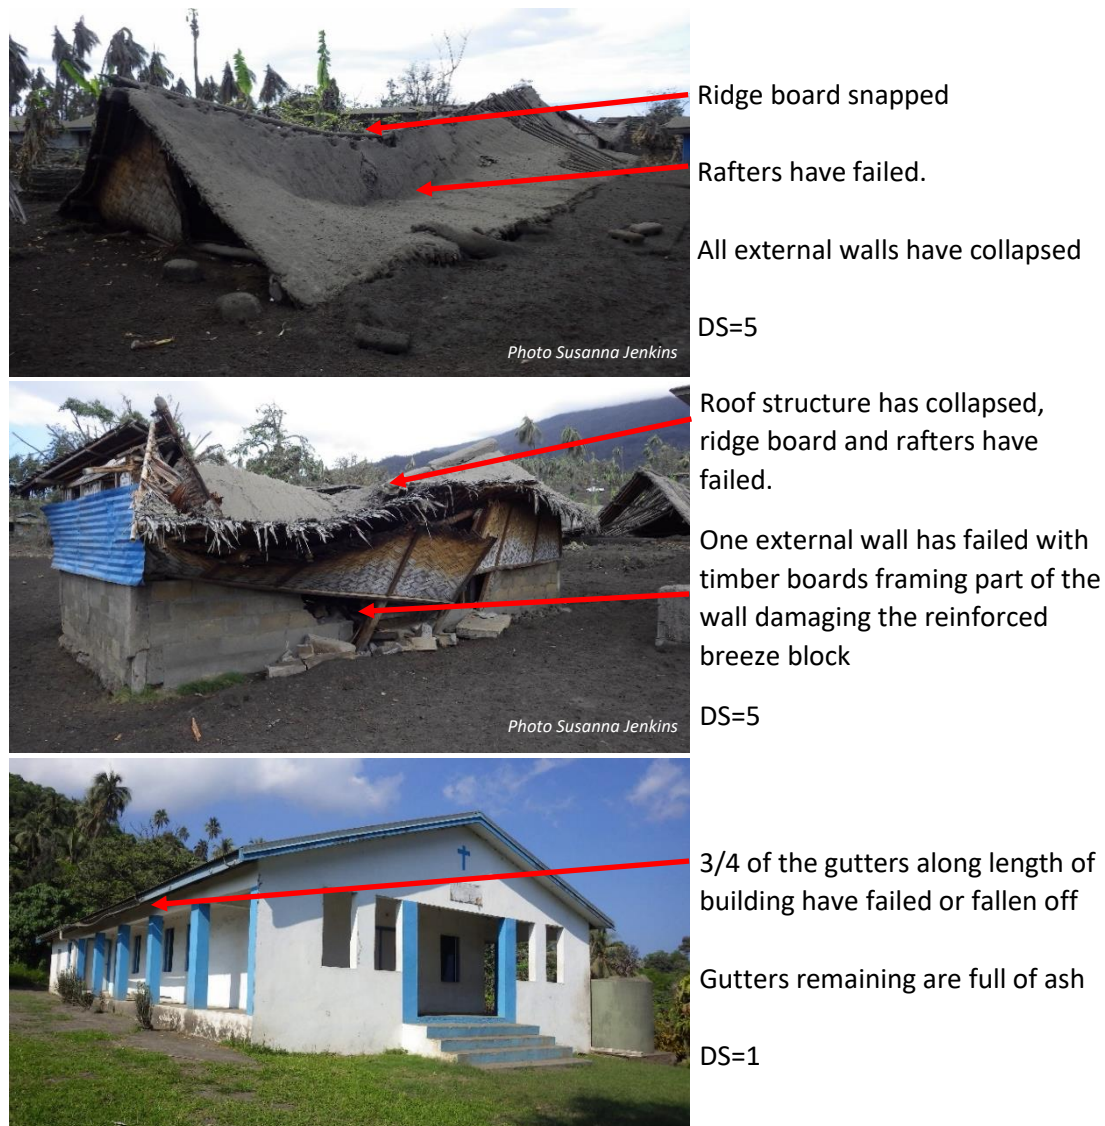
Figure 4.3 Examples of photographs used to describe the damage buildings sustained from tephra fall with the damage descriptions and corresponding damage state given to them

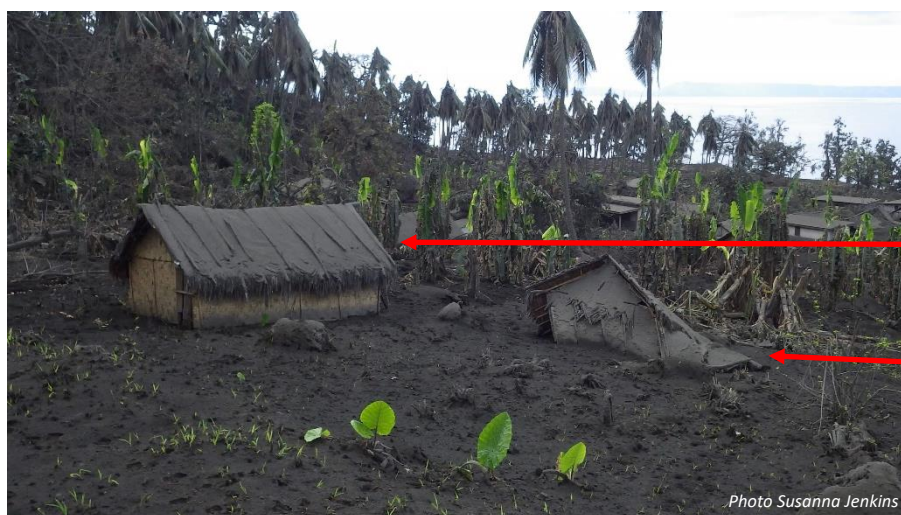
Two traditional buildings with comparable construction characteristics

Figure 4.6 Two comparable traditional buildings that sustained different extents of damage from tephra fall

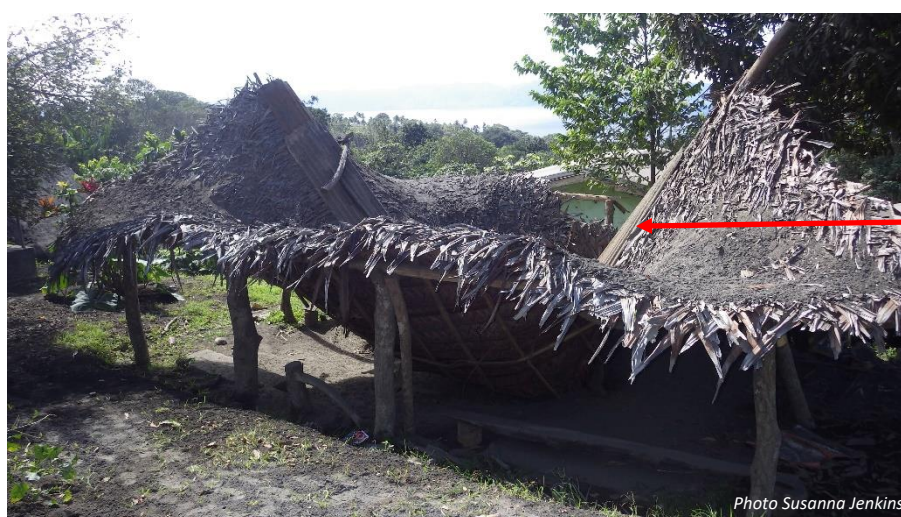
Failure in the apex beam resulting in roof collapse over more than 50% of the floor area of the building (DS5).

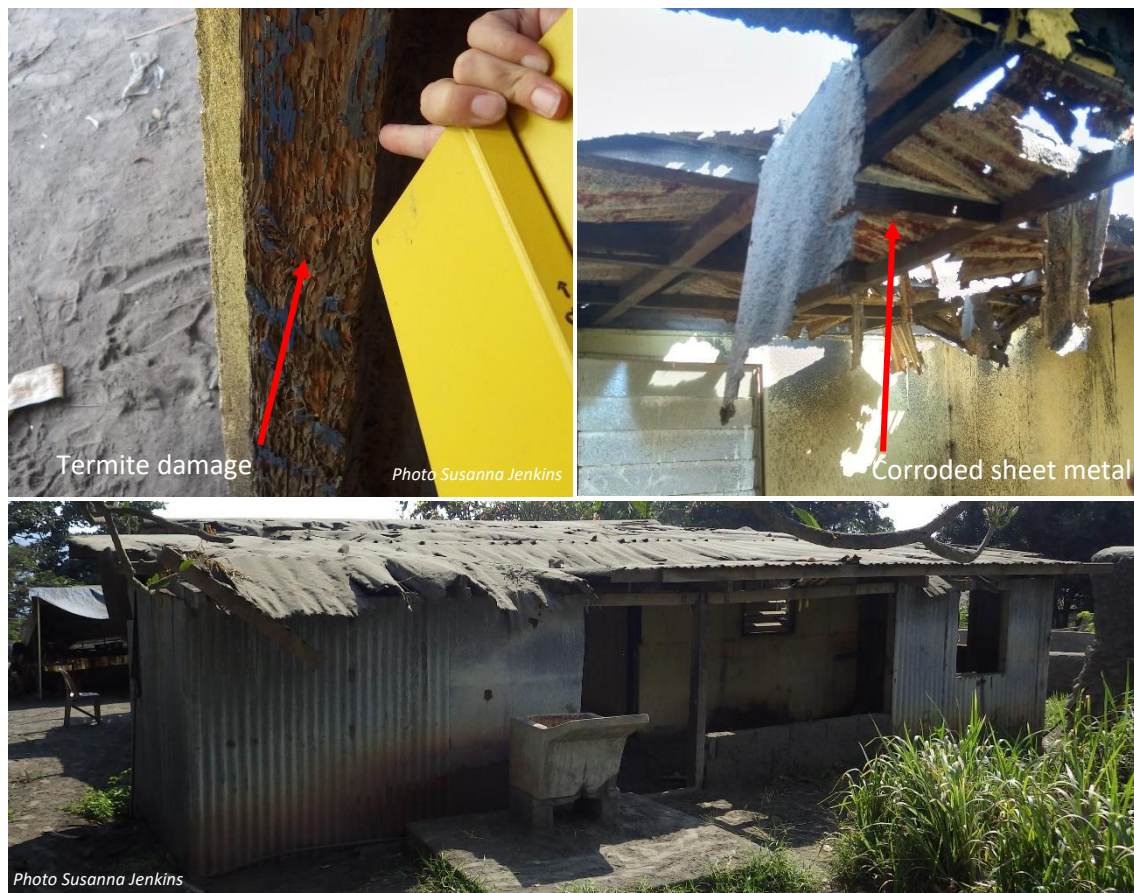
Figure 4.9 Non-traditional building exhibiting a poor pre-eruption condition with termite damage and corroded sheet metal roof increasing the building's vulnerability to tephra fall and resulting in severe damage from 30 mm of tephra fall

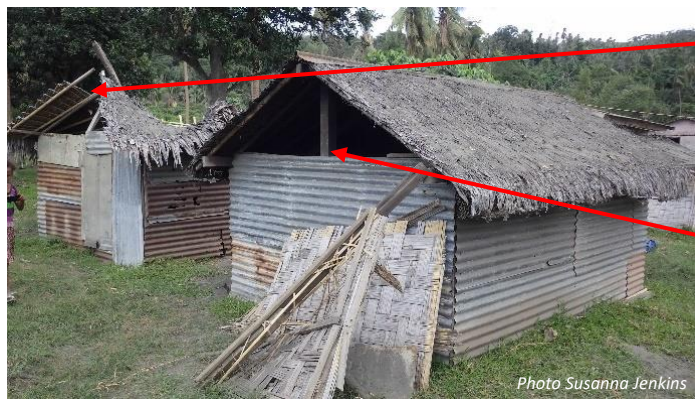
Traditional thatch roof framed with bamboo sustaining roof collapse at ~47 mm of tephra.

Traditional thatch roof framed with sawn timber sustaining no damage at ~47 mm of tephra.

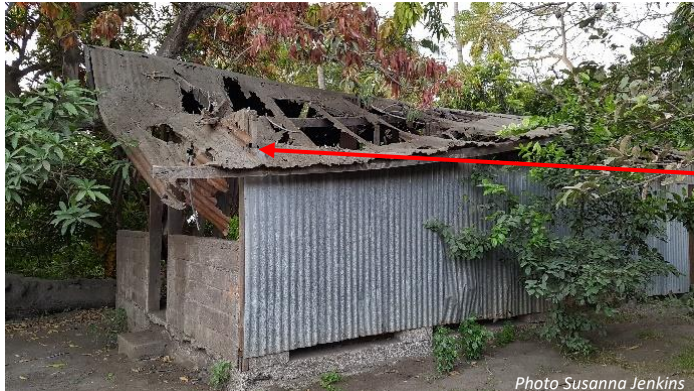
Hybrid building in a poor pre-eruption condition with the corroded corrugated sheet metal roof failing at ~40 mm of tephra.

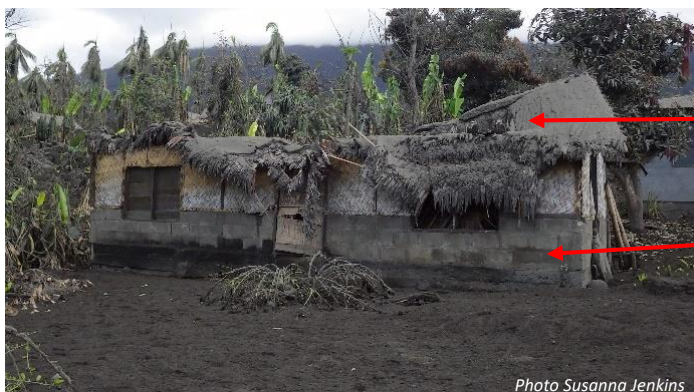
Hybrid building where the traditional construction features have failed from ~123 mm of tephra.

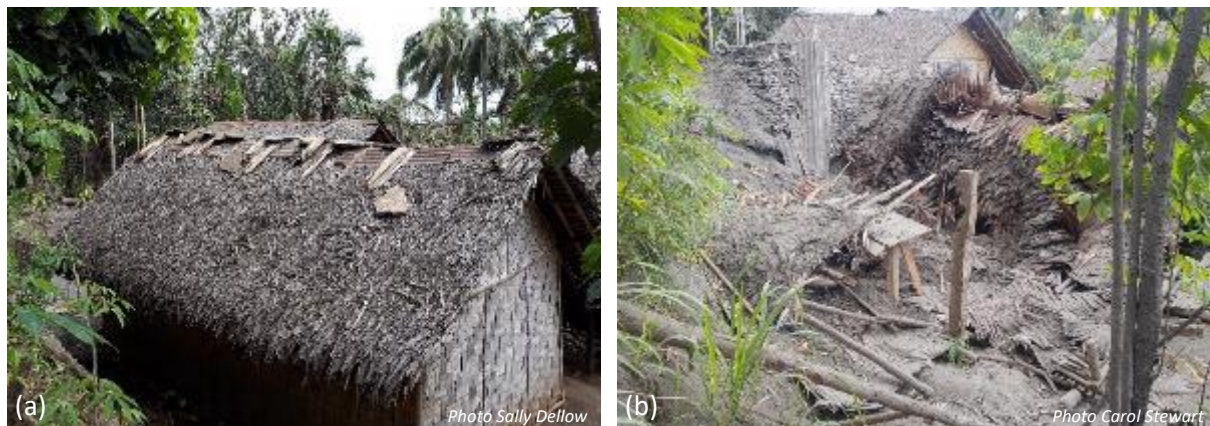
Figure 4.12 Longitudinal building damage observed in Lolombinanungwa village, West Ambae. (a) Building ID 43 after 53 mm of tephra during the March/April 2018 tephra falls. (b) The same building following a further 38 mm of tephra during the July 2018 tephra falls.

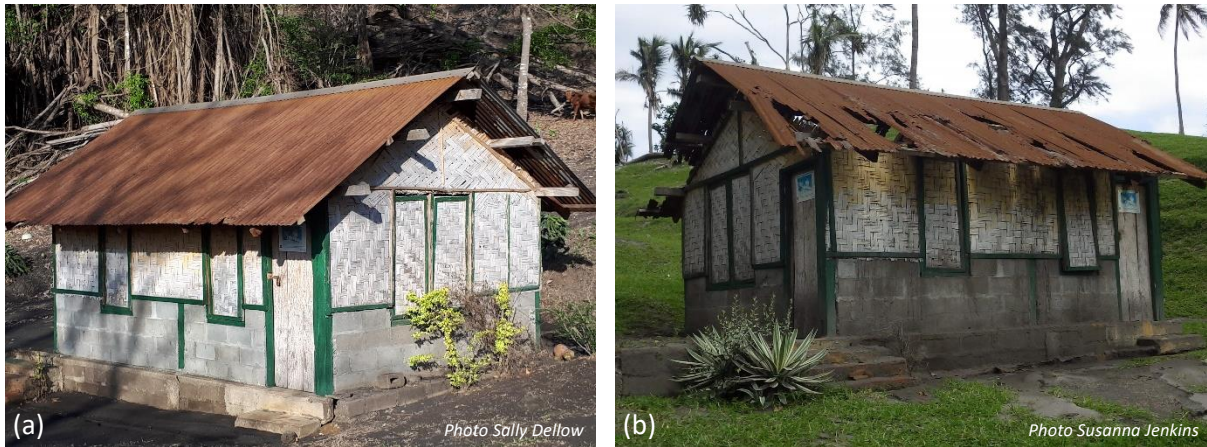
Figure 4.13 Longitudinal building damage observed in Red Cliffs, South Ambae. (a) Building ID 04 after 215mm of tephra during the March/April 2018 tephra falls. (b) The same building following a further 26mm of tephra during the July 2018 tephra falls.

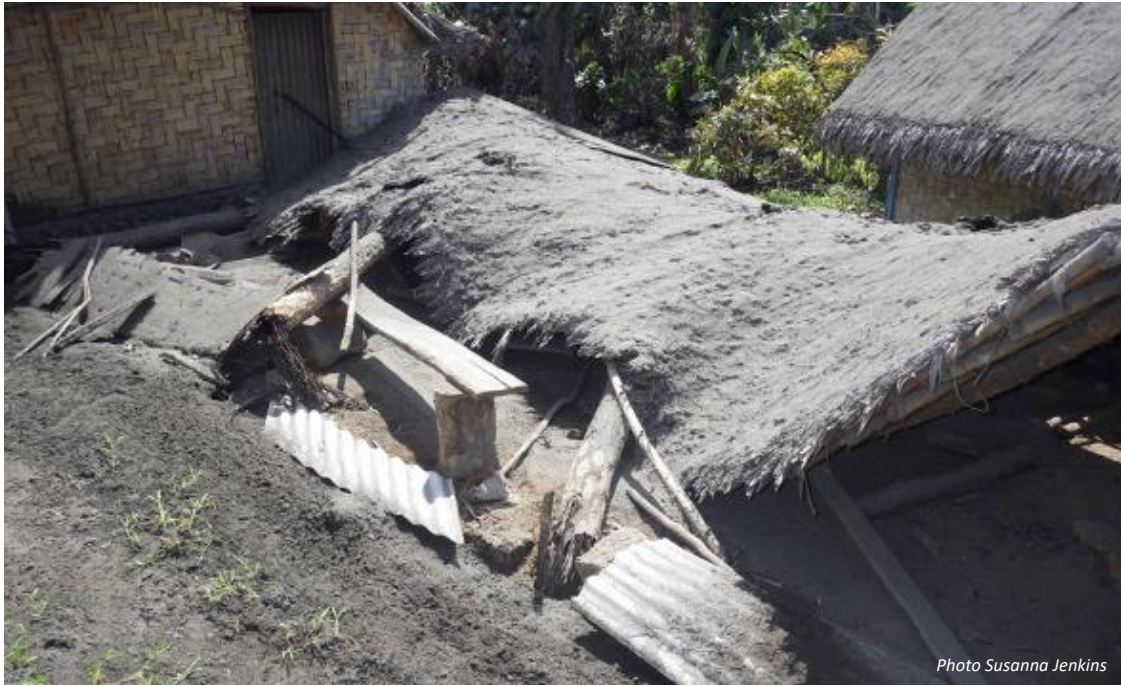
Figure 4.14 Complete collapse of an open-sided traditional building, where the vertical load-bearing props (tree trunks) snapped at their base. (55 mm)	62
Figure 4.15 Roof collapse of an open-sided traditional building where the primary beam broke, but the vertical load-bearing props remain intact. (53 mm)	62
Figure 4.16 Roof collapse of a traditional building, where the vertical load-bearing props and apex beam remain intact (in the front section), but the principal rafters are detached and damaged. (134 mm)	63

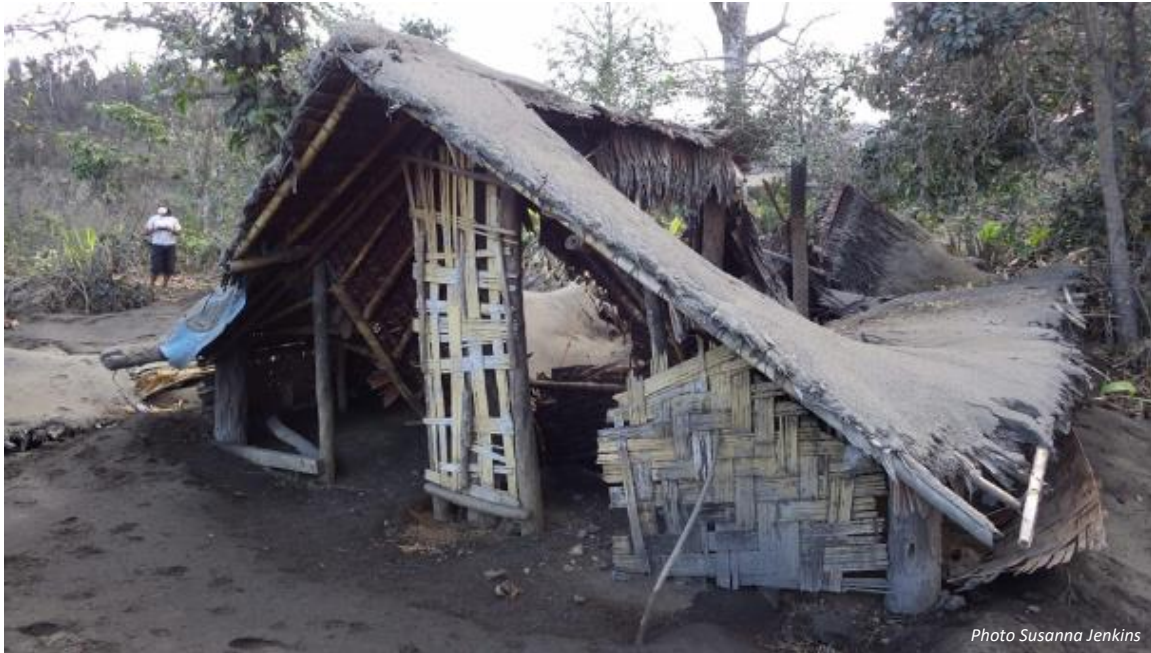
Figure 4.16 Roof collapse of a traditional building, where the vertical load-bearing props and apex beam remain intact (in the front section), but the principal rafters are detached and damaged. (134 mm)

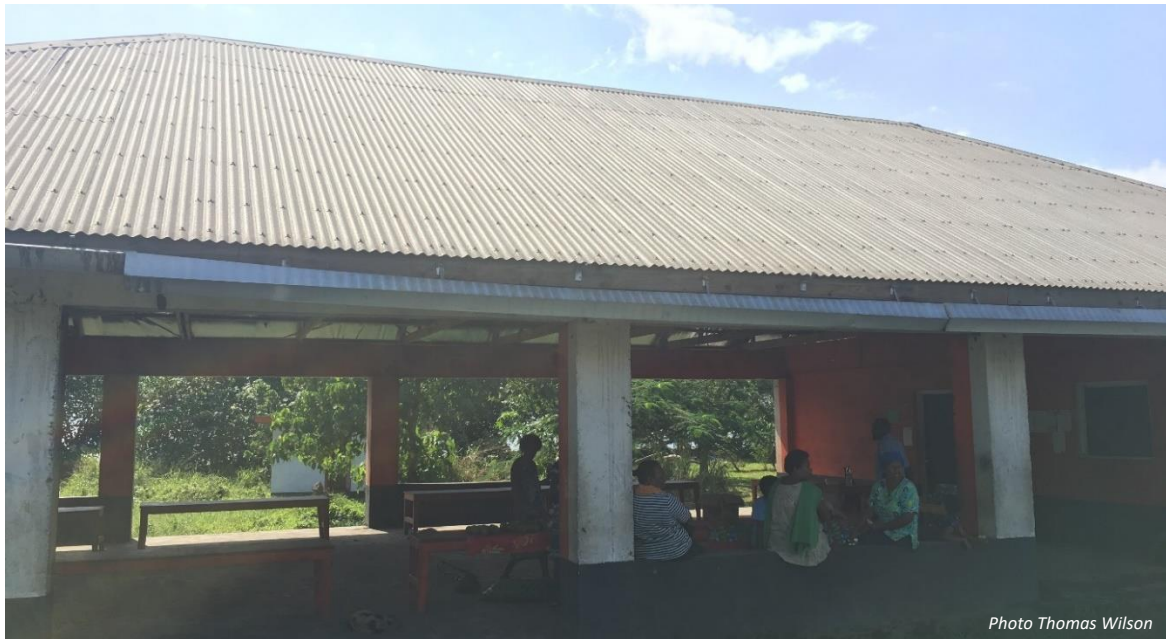
Figure 4.17 Building ID 114 represents the lowest threshold of tephra fall causing gutter damage with 9 mm. This low threshold is attributed to the large surface area of the roof being able to collect a greater volume of tephra.

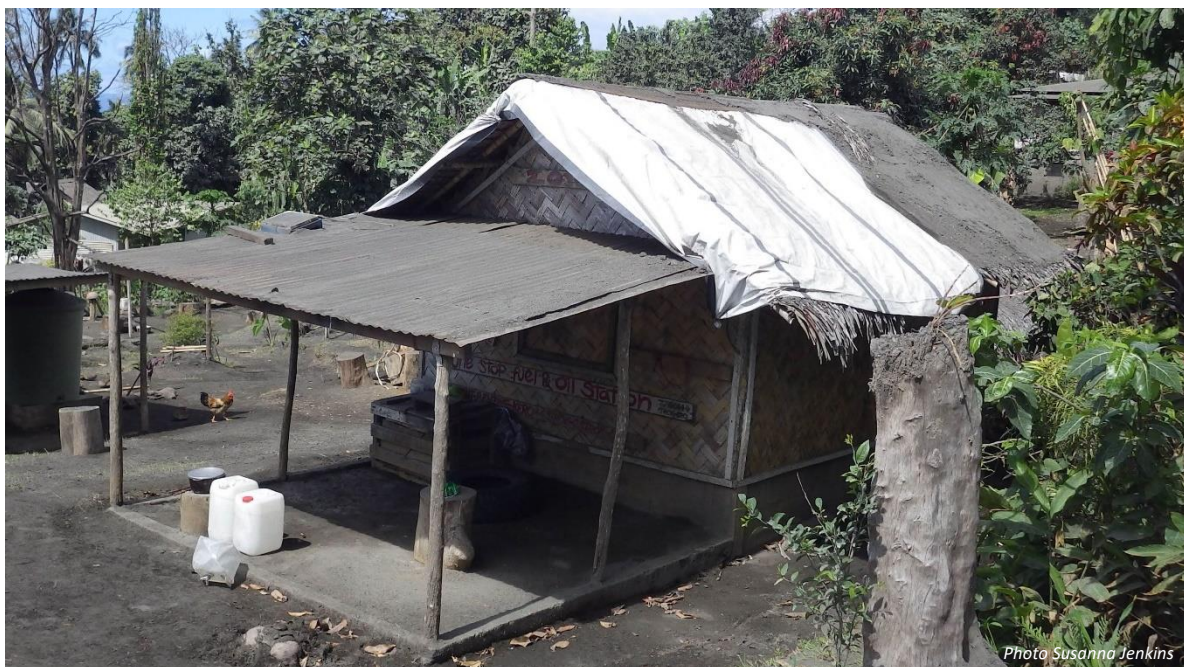
Figure 4.18 Ambae building with a traditional thatch roof, partially covered with a tarpaulin. The portion of the roof covered with the tarpaulin has already shed most of the tephra, whilst the portion of the roof with no tarpaulin continues to retain tephra.

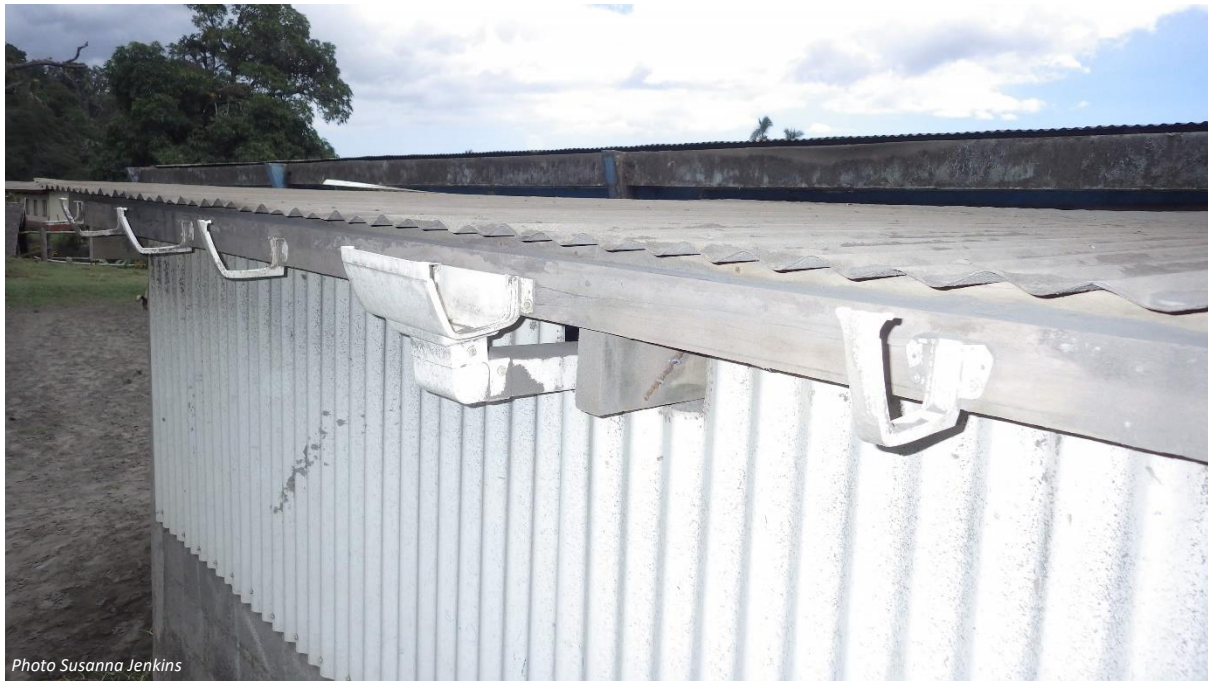
Figure 4.20 Roof structure that shelters a water tank had its gutters removed during tephra fall so that tephra could not contaminate the drinking water source and subsequently prevented gutter damage from tephra loading.

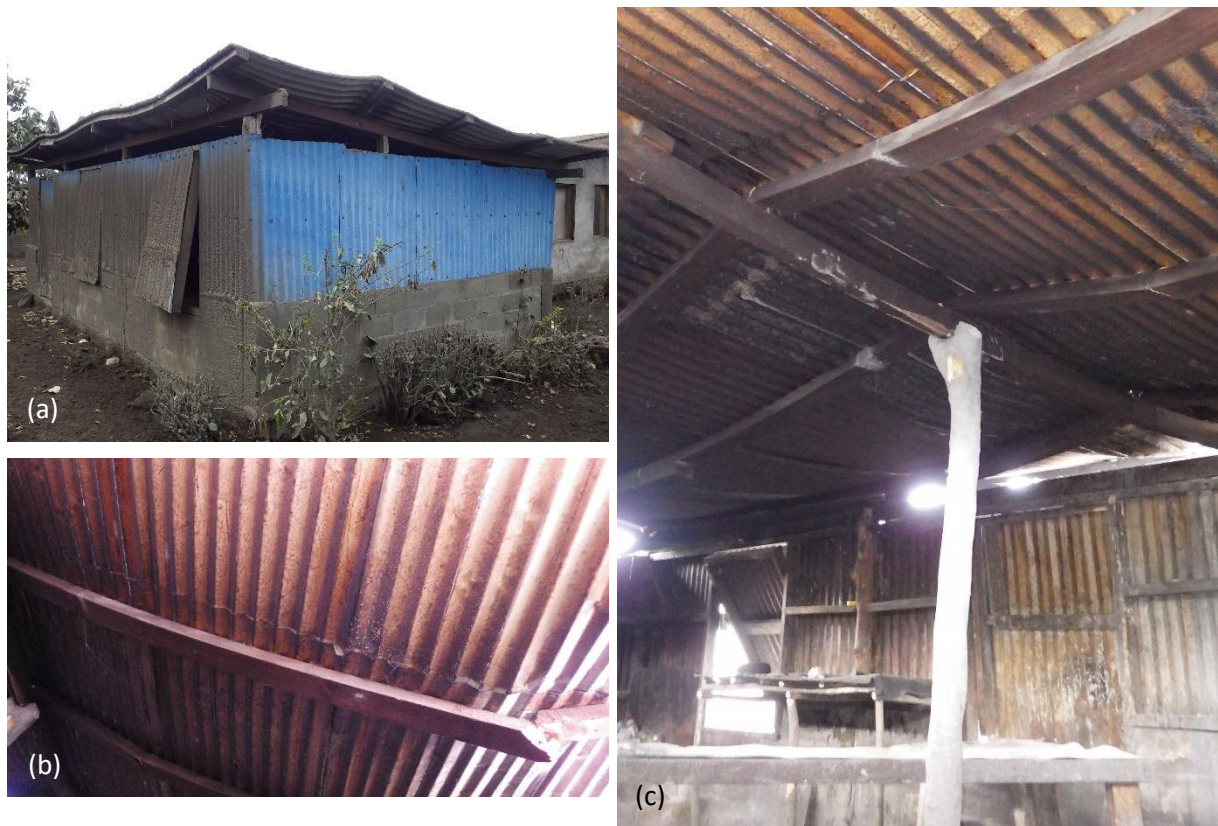
Figure 4.21 Building ID 258 exposed to approximately 126 mm of tephra during the July 2018 eruption phase. (a) exterior of the building with visible bending in the corrugated sheet metal roof cover. (b) Purlin beam which had snapped from the tephra loading and bending roof cover. (c) Pole installed to reinforce the roof support structure along with extensive bending in the roof cover and support. (Photo credit Susanna Jenkins)

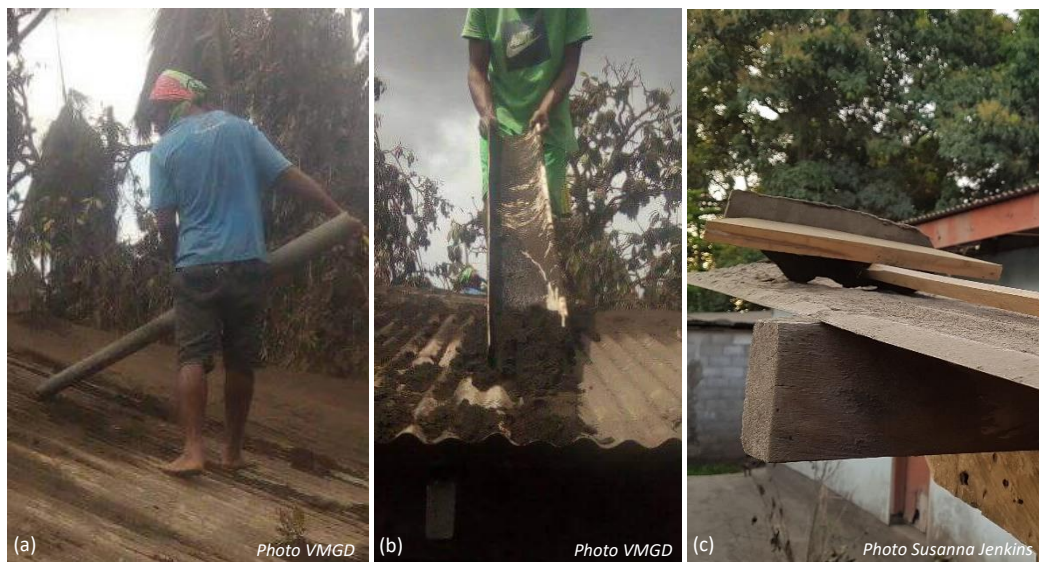
Figure 4.22 Innovative methods used to clear tephra off roofs on Ambae. (a) Plastic half pipe. (b) Length of guttering. (c) Homemade rake with inbuilt corrugation pattern.

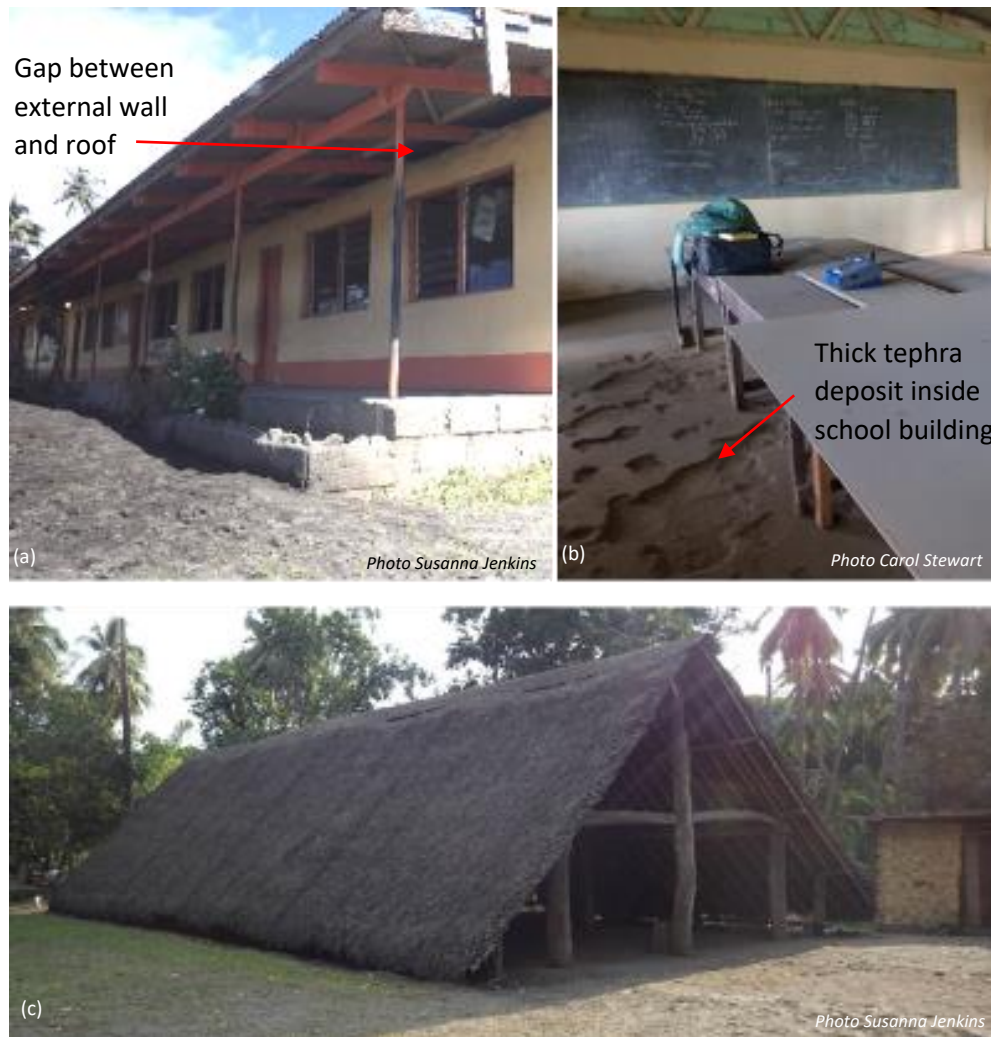
Figure 4.23 Characteristics of Ambae buildings which make them vulnerable to tephra ingress reducing their habitability. (a) School building, Lovunivili village, East Ambae with a gap between the external wall and roof structure, and louver windows. (b) Interior of the school building with a thick tephra deposit inside from ingress. (c) Traditional Nakamal with exposed openings at either end of the building which allowed tephra into the building during the July 2018 tephra falls.

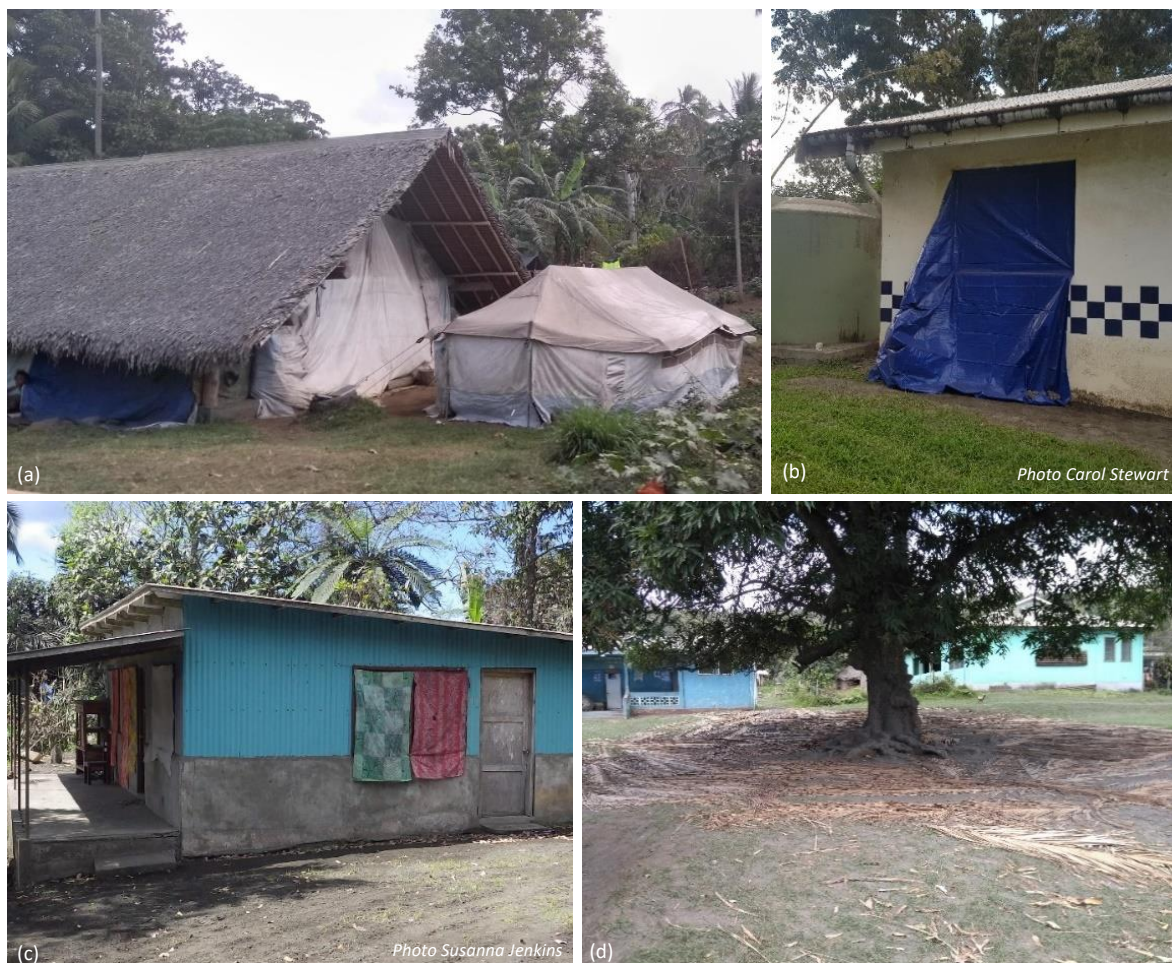
Figure 4.24 Mitigation techniques observed in Ambae for minimising tephra contamination in buildings. (a) covering on large openings on traditional buildings (b and c) covering of small window openings (d) coconut leaves scattered over an area of barren tephra-coated land with high foot traffic.
